HISTORIC STRUCTURE REPORT

COIT TOWER SAN FRANCISCO, CALIFORNIA

Dan Peterson, AIA, Historical Architect
Geraldine Peterson, Designer - Preservation Specialist
Ann-Marie Meenahan, Designer - Preservation Specialist
Interactive Resources, Inc.
Architects and Engineers
117 Park Place
Point Richmond, CA 94801
415-236-7435
Fax: 415-232-5325

April 1989

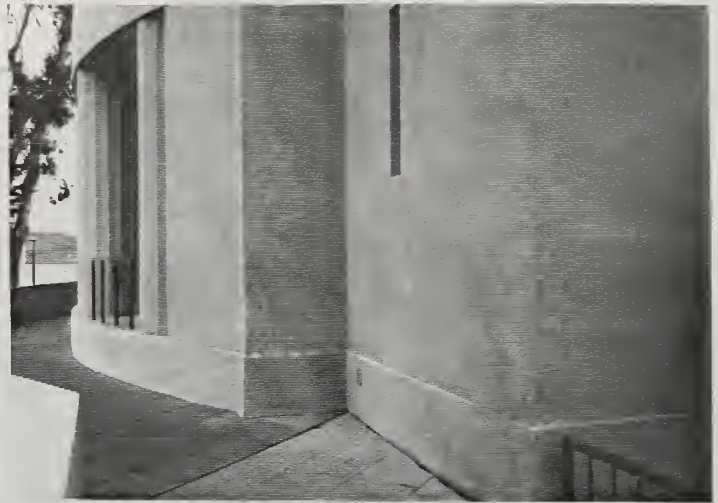
E-3. Dash coat after attempt at removing stain. (52-17)

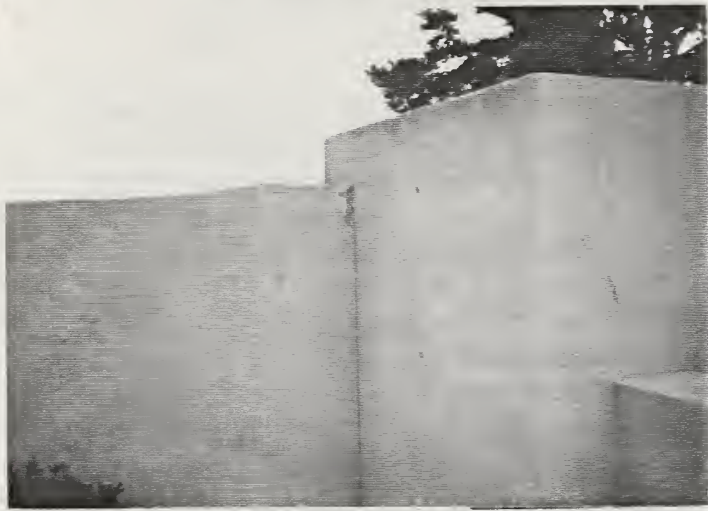
E-5. An area of planters that requires repair. (49-7)

Preservation Treatment: The terrace retaining walls and planters should be periodically maintained only when necessary by removing the stains with the gentlest methods possible. The Historical Architect recommends the use of *Sure Klean* "Defacer Eraser" or "Graffiti Control"

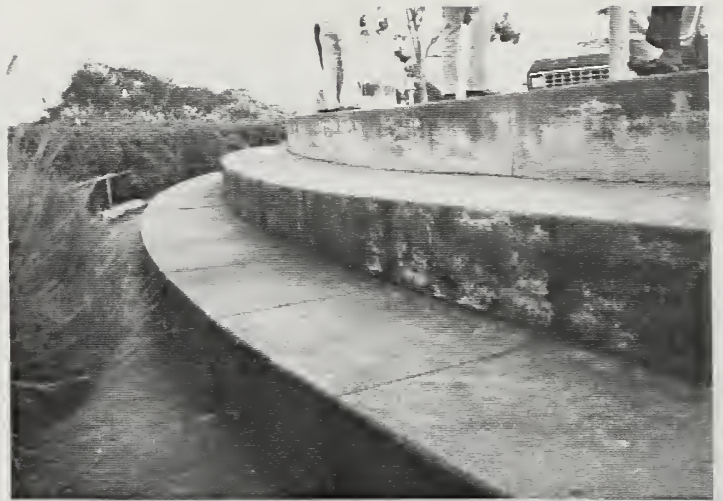
E-6. Condition of steps at parking lot retaining wall. (54-24)

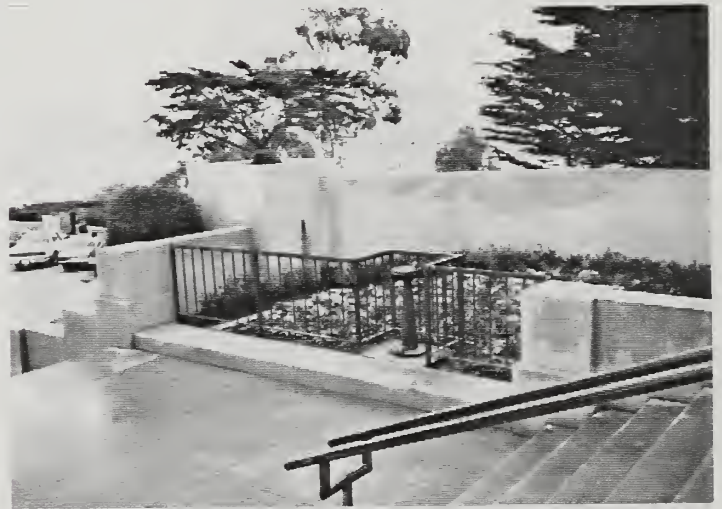
E-8. Retaining wall and planters after a rain. Notice stain under weep hole. (49-8)

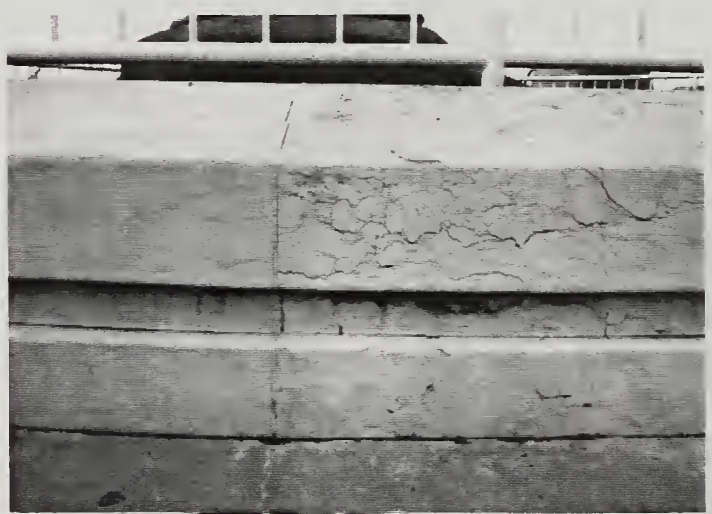
E-10. Detail of condition
of marble. (48-2)

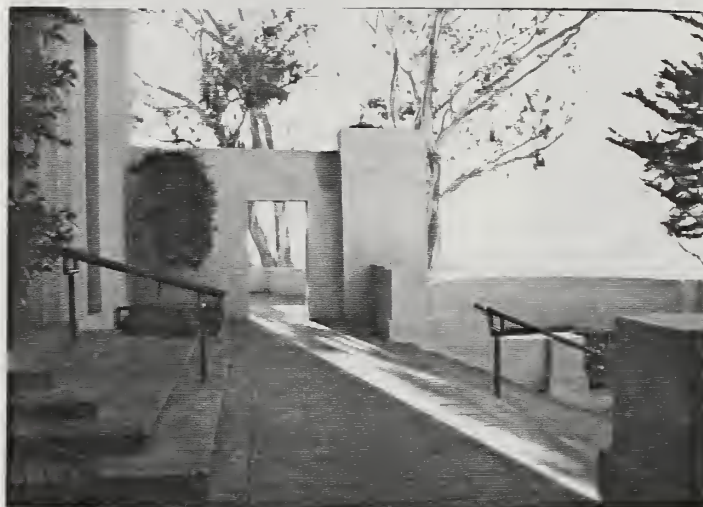
E-11. Entrance Porch with new concrete steps on the left, covering red concrete pattern. (46-21)

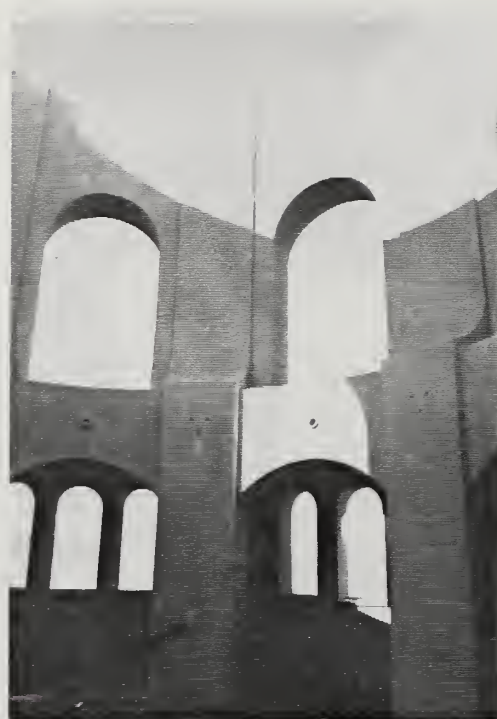
E-23. Water stains from scuppers. (34-1A)

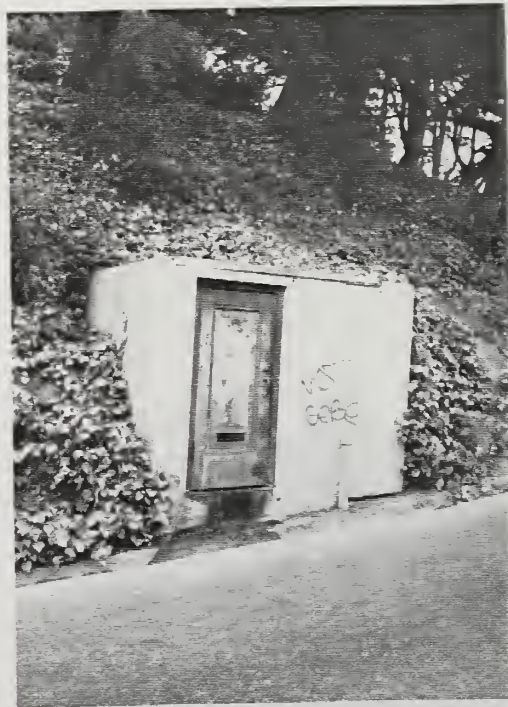
E-25. Pump house. (85-7)

Preservation Treatment: The graffiti should be washed off. The Historical Architect recommends conducting a vapor transmission characteristics evaluation utilizing laboratory tests. The *Sure Klean* "Defacer Eraser" or "Graffiti Control" products by the company ProSoCo, Inc. in Kansas City, Kansas could then be used matching the vapor transmission of the existing surfaces, as recommended on pages IV-1 and IV-2. The roof should be investigated as well as the interior of the pump house to estimate the damage to the pump. See pp. 13 - 15, Sec. of Interior Guidelines.

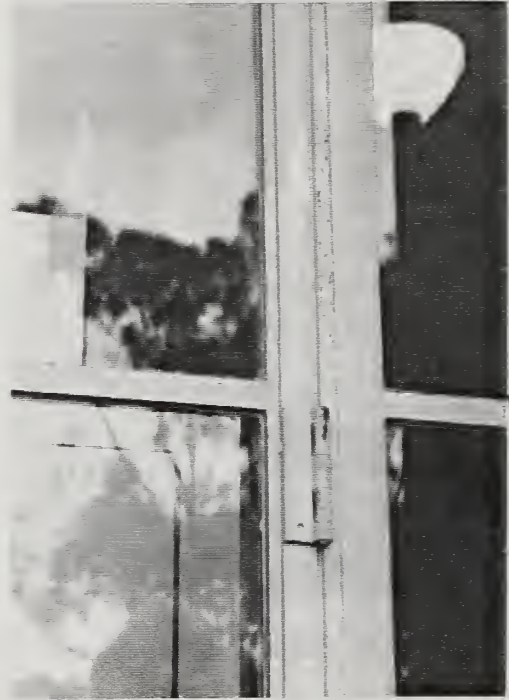
E-42. Detail of Gallery glass and metal doors. Scratched paint reveals aluminum color. (85-05)

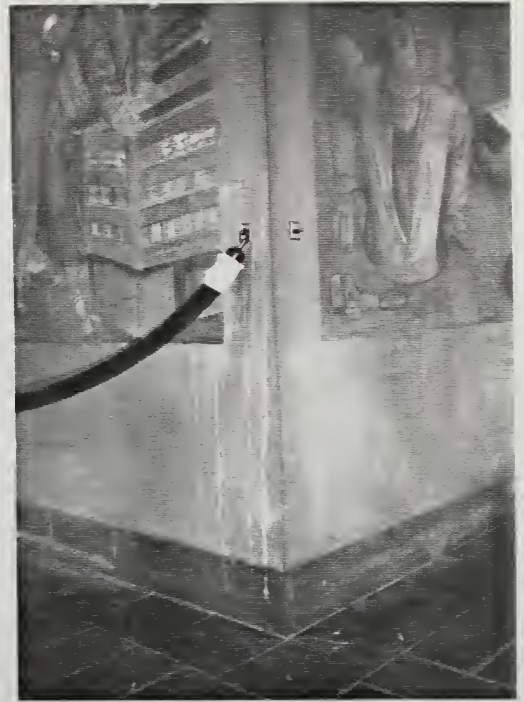
I-12. Typical
condition of
plaster walls
in Galleries.
(78-17A)

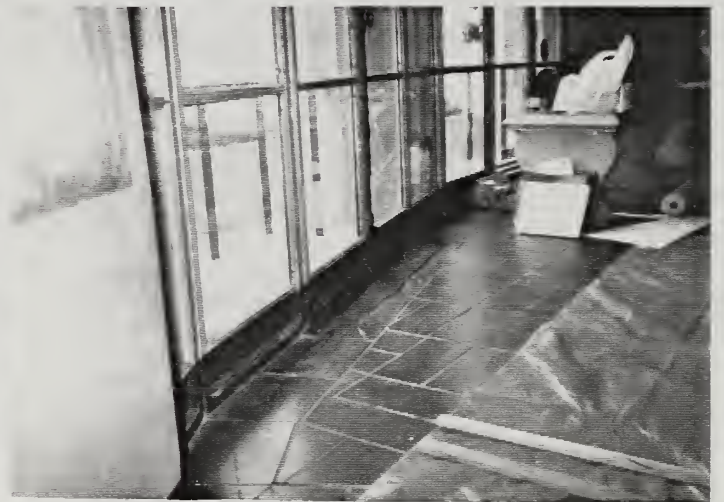
I-14. Cracks in quarry tile near
glass doors. (77-13A)

a. Lobby Tile Crack - The report included recommendations for the replacement of quarry tiles at a severe crack near the West wall of the Lobby. It also suggested to investigate the soil below the slab to determine if additional settlement may occur.⁴

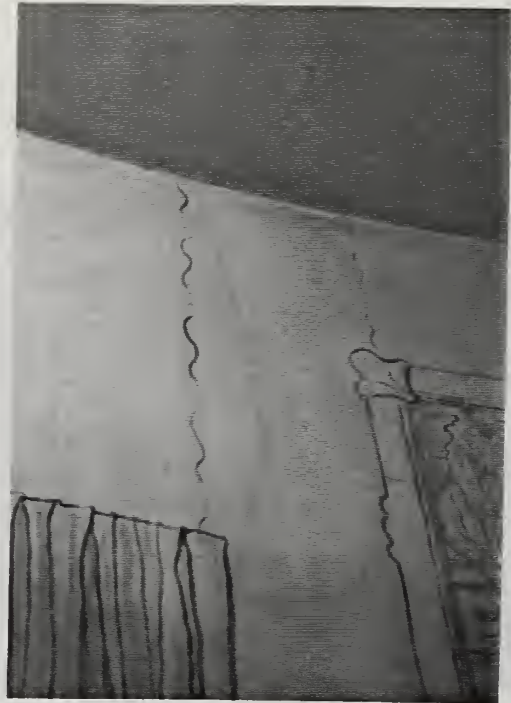
I-20. Typical crack on wall and ceiling. (59-14)

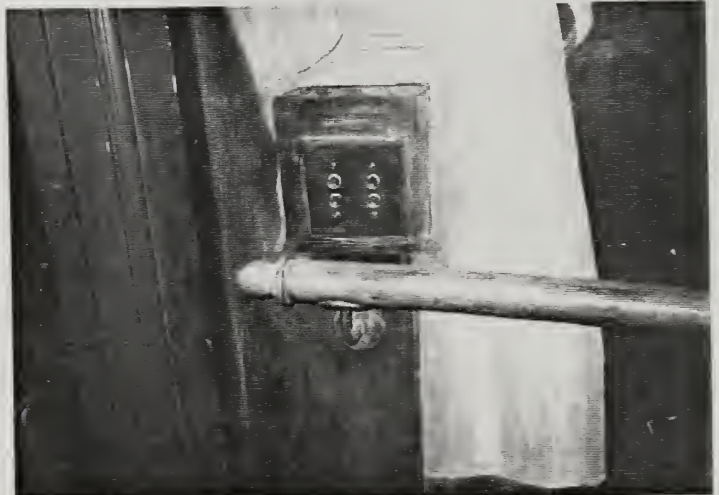
I-26. Metal key operated light
switch. (56-04)

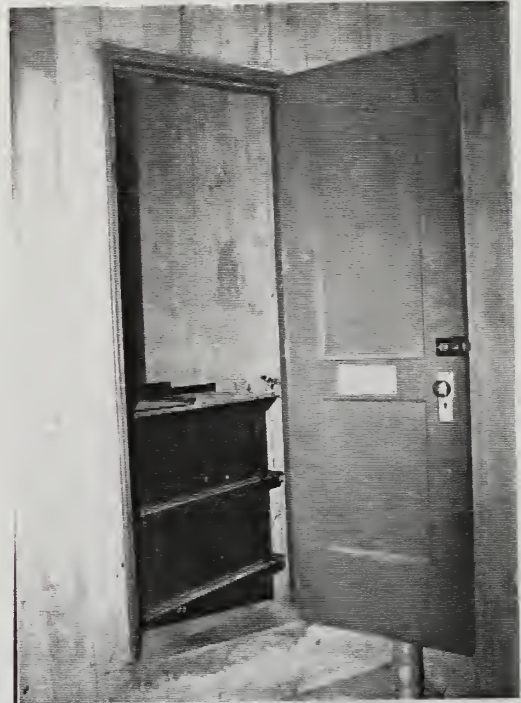
I-28. Typical painted wood door.
Water tank. (20-11A)

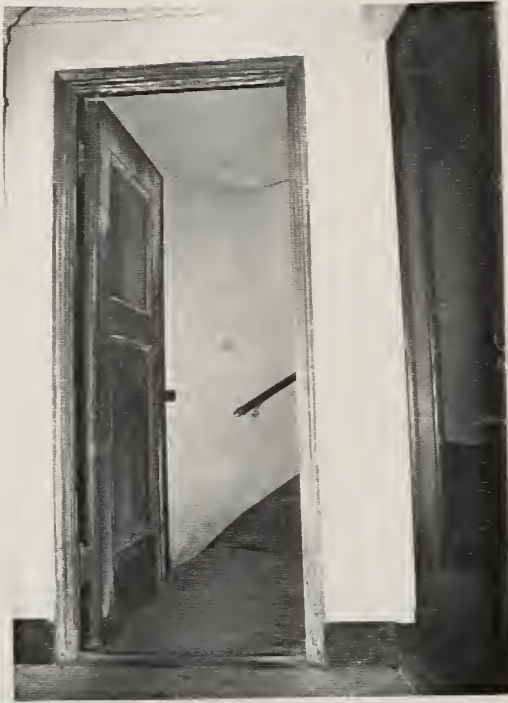
I-31. "Kalamein" exterior door.
Metal mesh mechanical room door.
(19-07A)

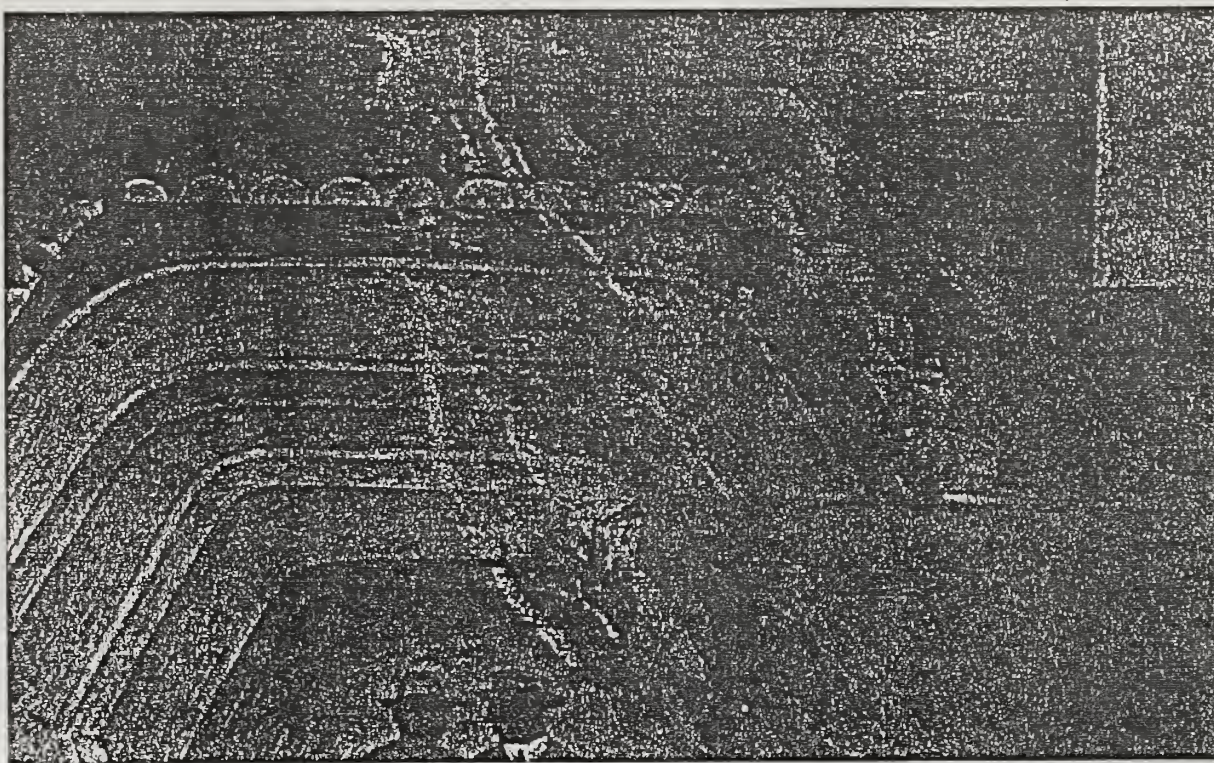
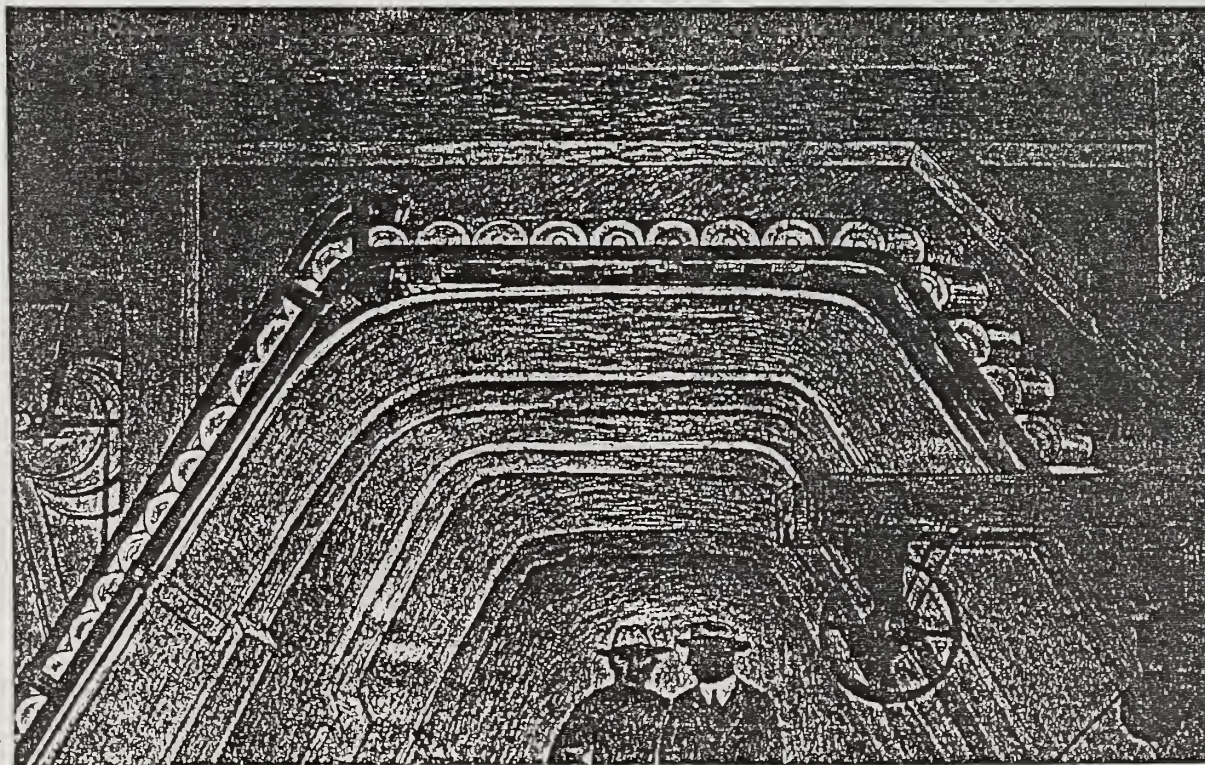
RALPH STACKPOLE - fresco, inner west wall. Photographs show rain damage at top right corner of this mural. The plaster in this area is quite rough. Lower photograph shows damaged areas after they were retouched with Liquitex (acrylic). Another area over the center door showed a white circle near the ceiling where water had seeped in. This, as well as several other smaller areas were matched with acrylic paint.

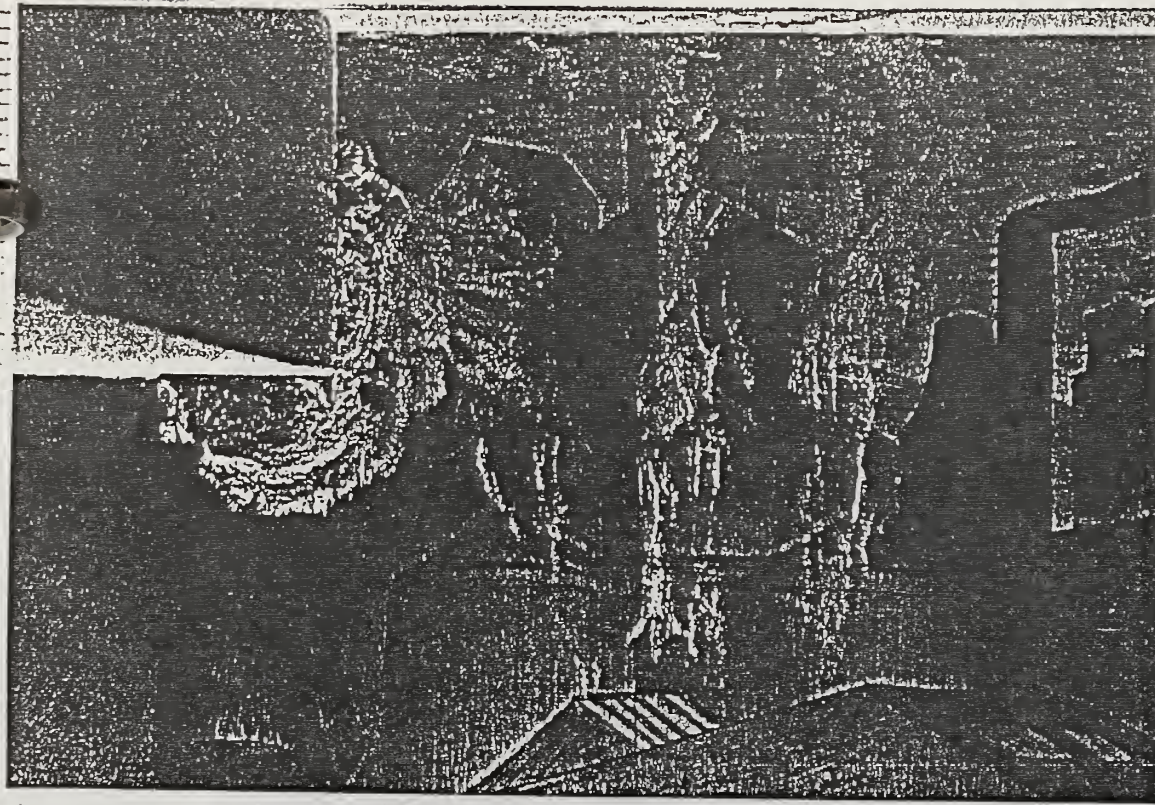
VICTOR ARNAUTOFF fresco - inner south wall. Extensive rain damage has weakened the plaster and destroyed some of the color from floor to ceiling. Color areas were retouched with acrylic (Liquitex). I replaced only a small area of plaster, and was surprised to find no wire mesh between the plaster and the smooth concrete wall. I hope this isn't the case throughout the building. At the top (see photographs) I think moisture may still be coming through. If this can't be stopped, the paint will continue to flake off.

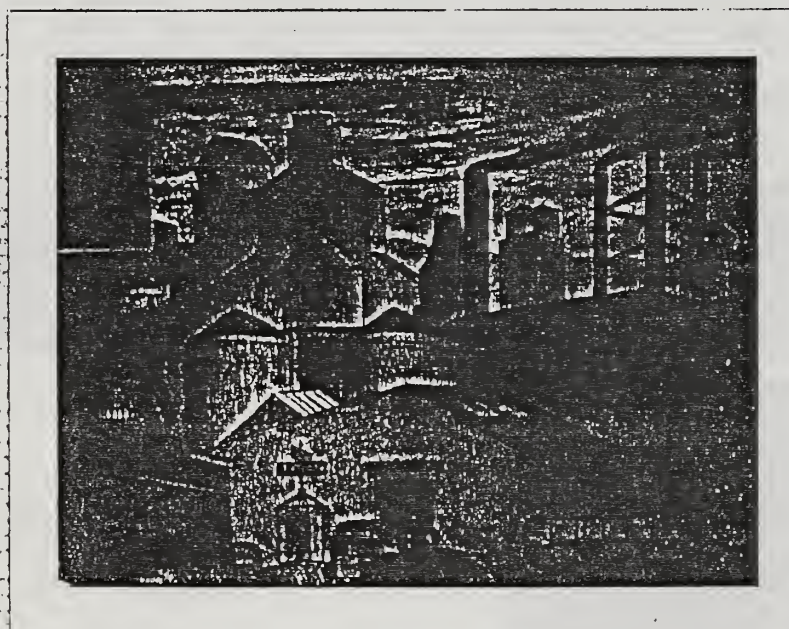
Arnautoff fresco after repair with lime putty and marble-dust, then acrylic (Liquitex) to complete retouching.

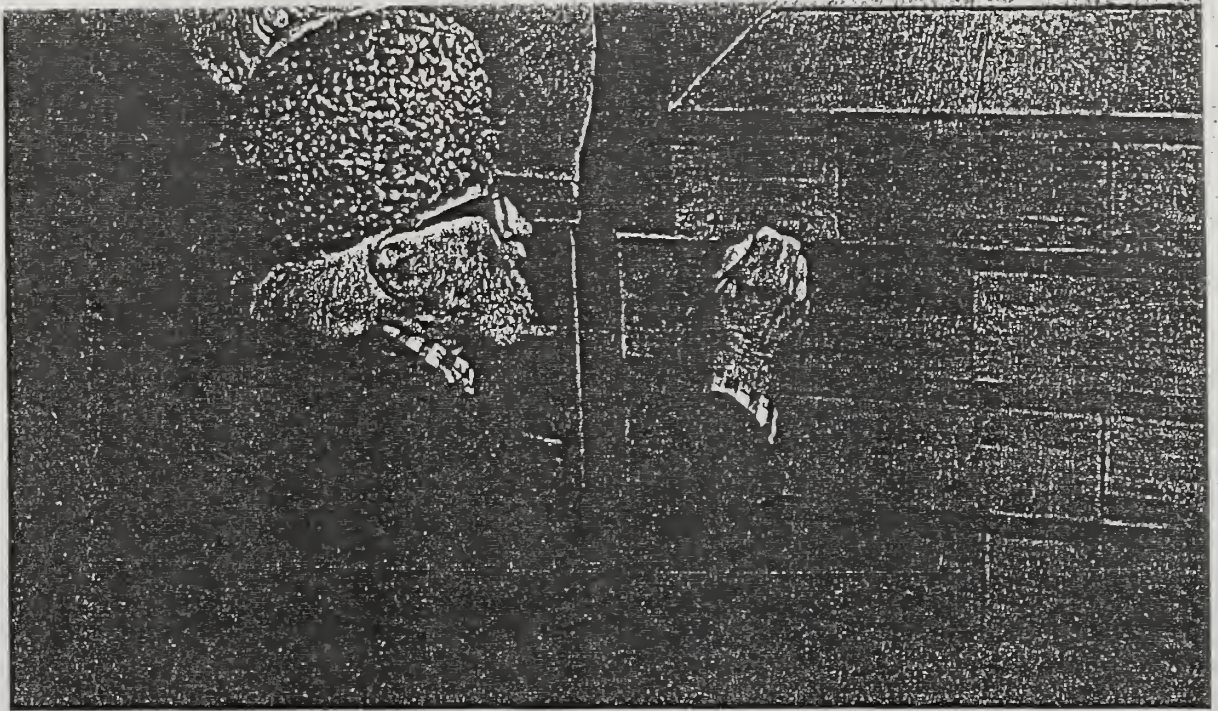
BERNARD ZAKHEIM re-signing his name where it had worn off as a result of rain leaking under the narrow window in the center of his library mural. (outer south wall) 1975

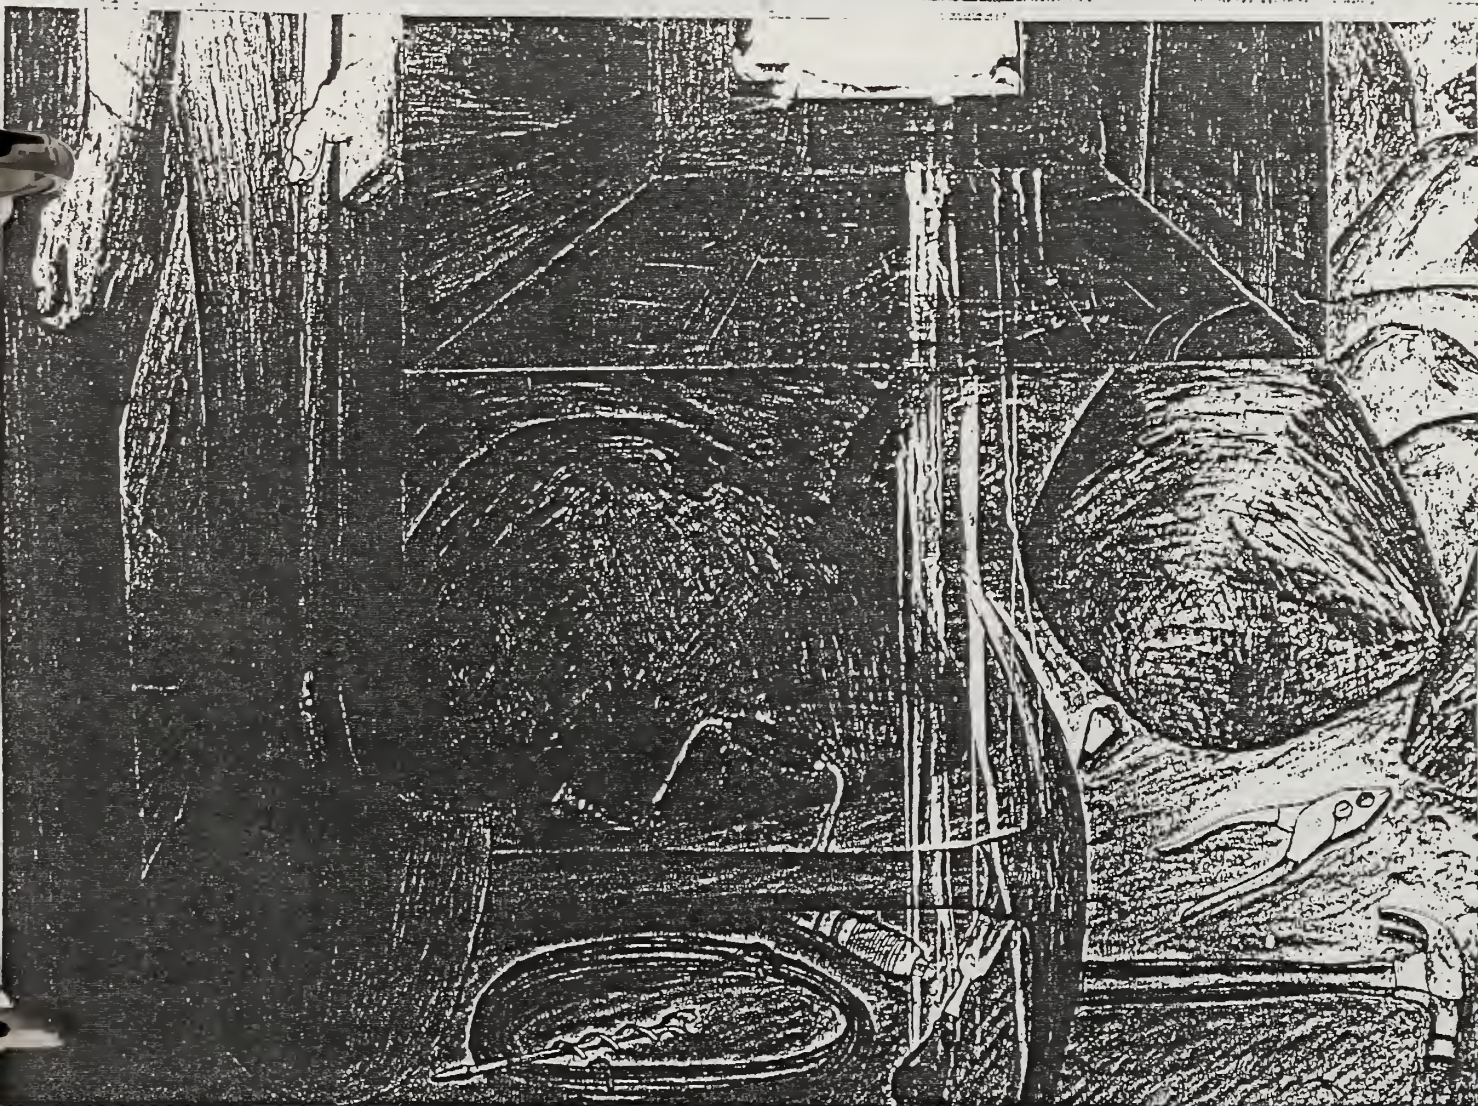
Rain damage under narrow window in fresco by John Langley Howard

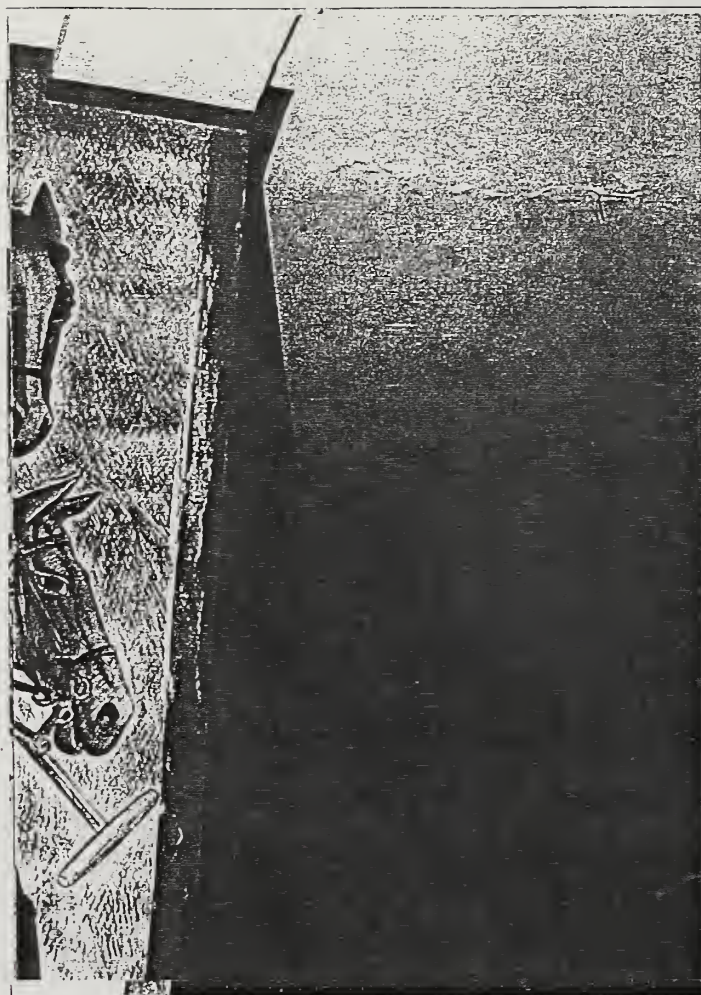
4. Second Floor landing. Water damage on ceiling and efflorescence of salts on the frescoes.

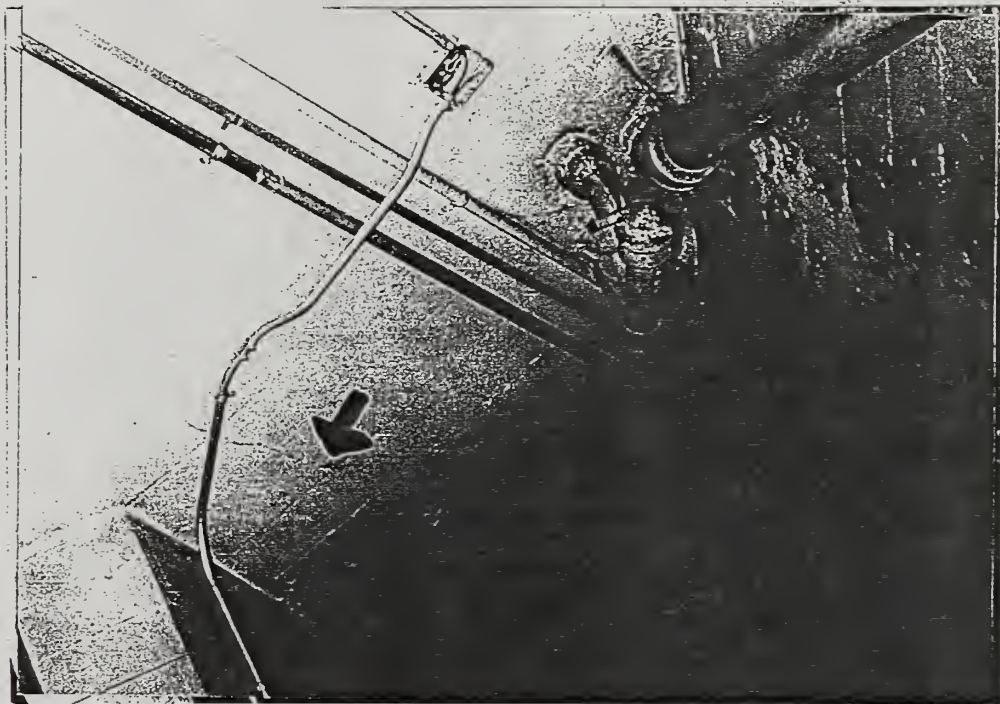
5. Ceiling of Ground Floor. During the second week of June, 1987. water dripped from a crack in the ceiling. Wall at right of photo supports frescoes.

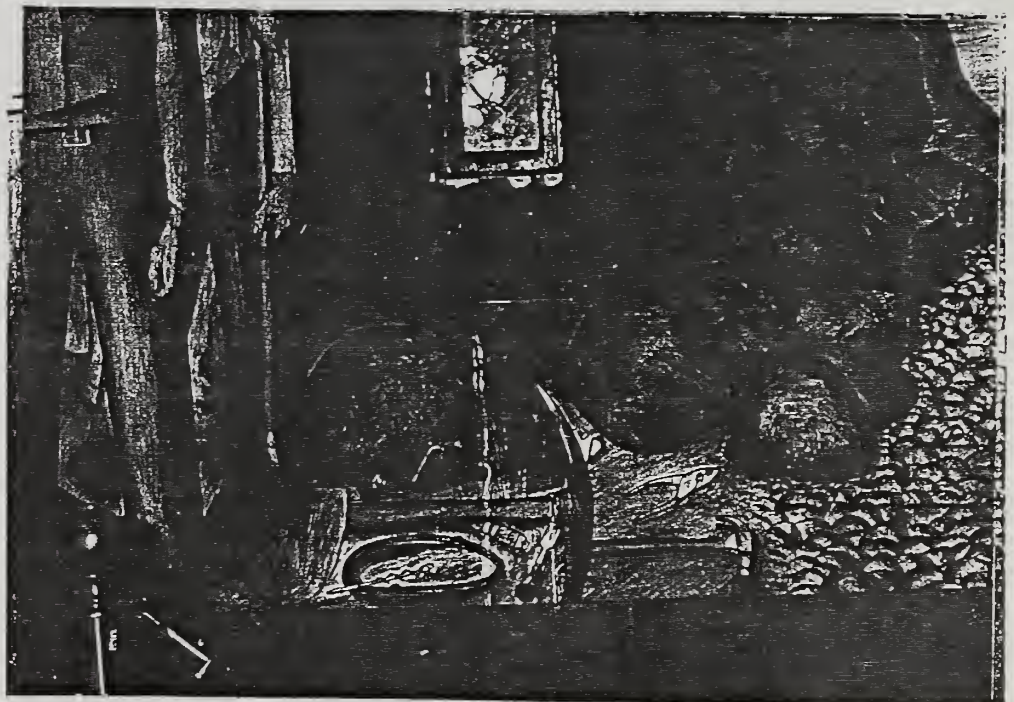
28.

Stains
before treatment
